Erosion and subsidence prevention at AS007 (BRDH) auxiliary seismic station for sustainable operation and maintenance

AS007, BRDH BARIYADHALA, CHATTOGRAM

EROSION AND SUBSIDENCE AT AS007

EROSION AND SUBSIDENCE PREVENTION ACTIVITIES

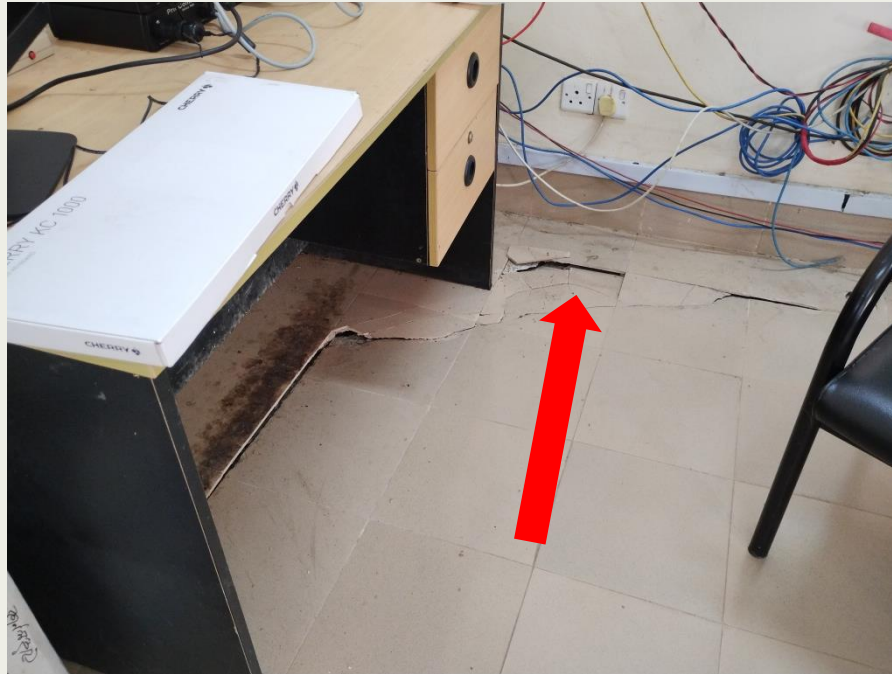
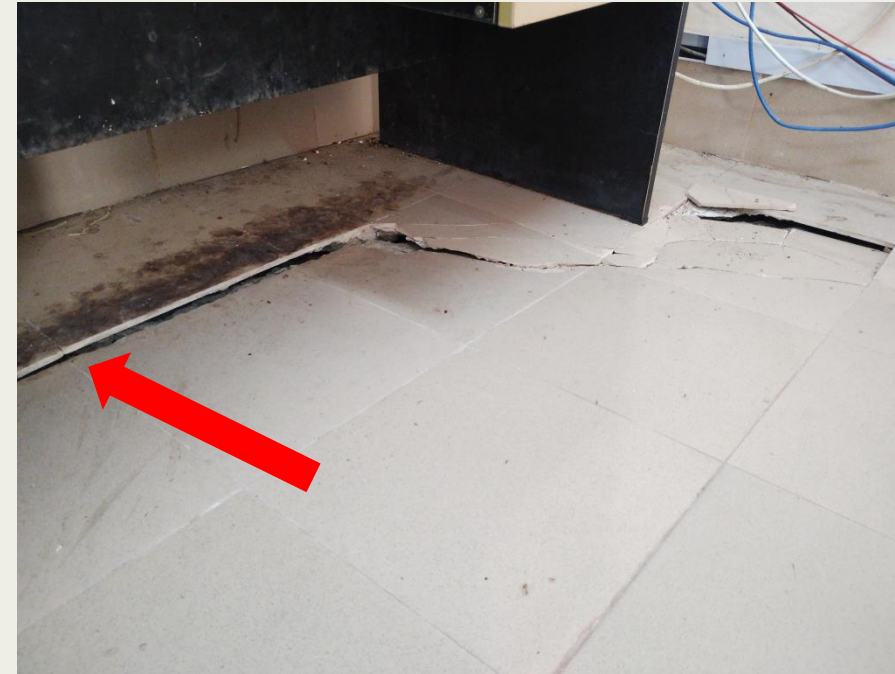
Inside the station building

- Lowering of floor Cracks first observed during 2021-22.
- Appeared from north-western corner of the building, continued at the entire west wall.
- In two years, the fracture width became more than 2 cm
- Distance of cracks from Seismometer- 7-8 feet

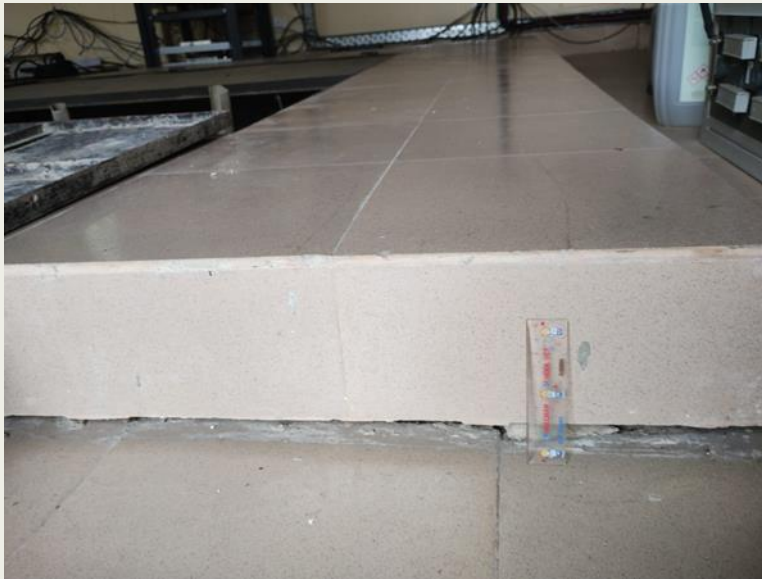
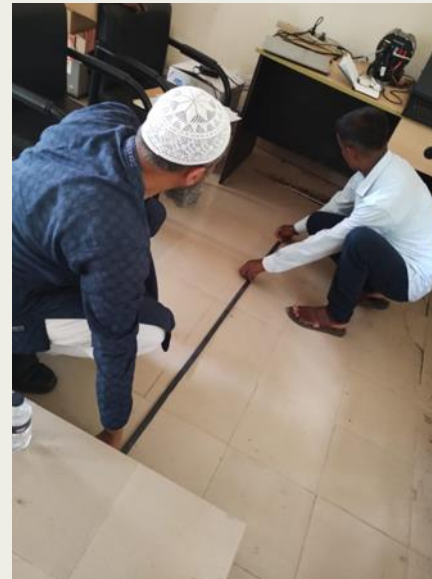
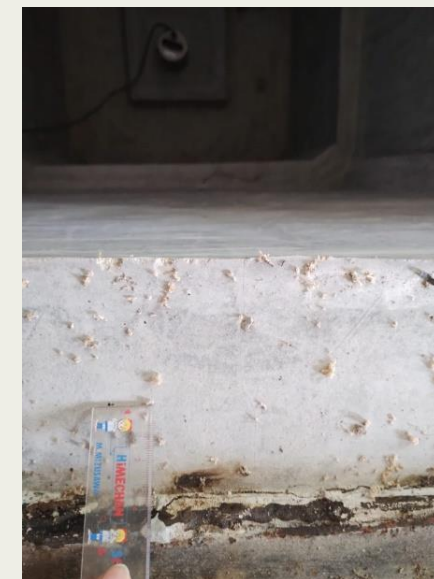
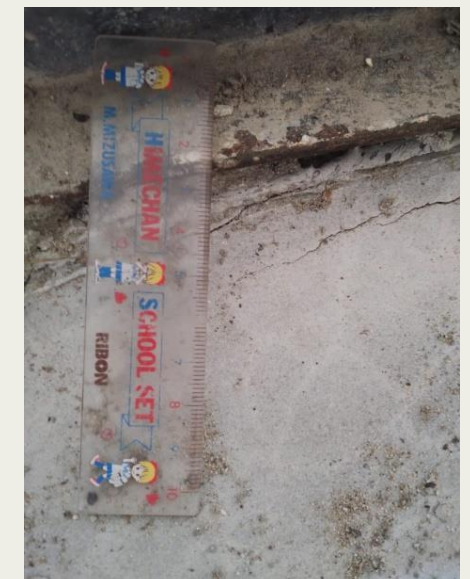
Inside the station building

- Cracks under the vault platform
- Fracture width at south side of vault- 1.8 cm
- Fracture at east side of vault- 1 cm
- Distance of cracks from Seismometer- 7-8 feet

Cracks of 0.5-1mm were first seen on Aug'24 at the vault structure

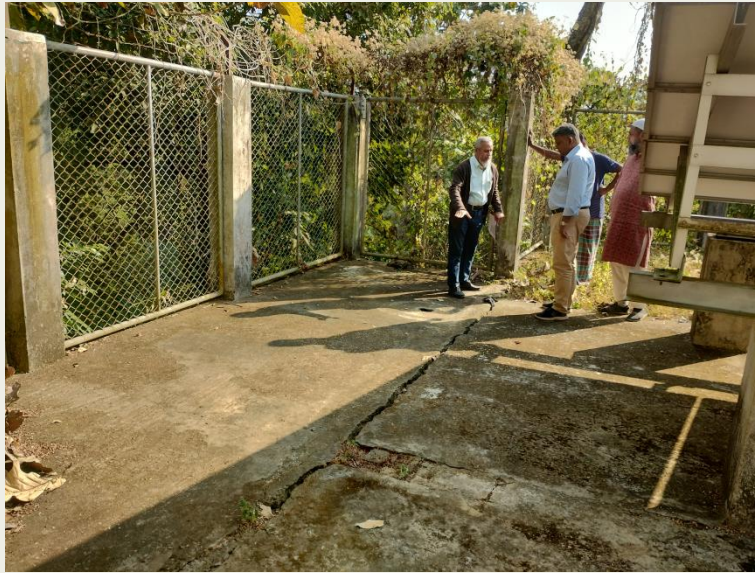
Cracks of more than 3 cm formed at outside of the building, only 3 feet from the solar panel, and 10 feet from Vsat.

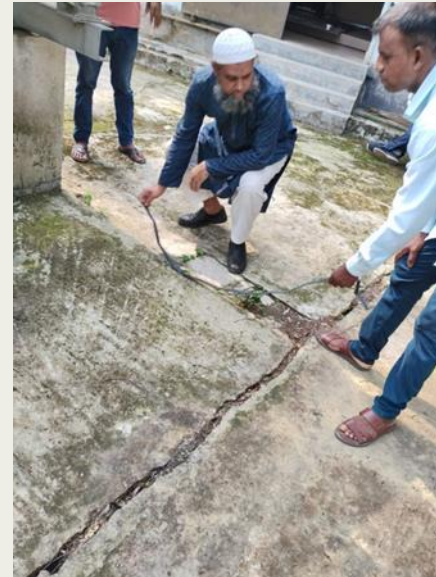
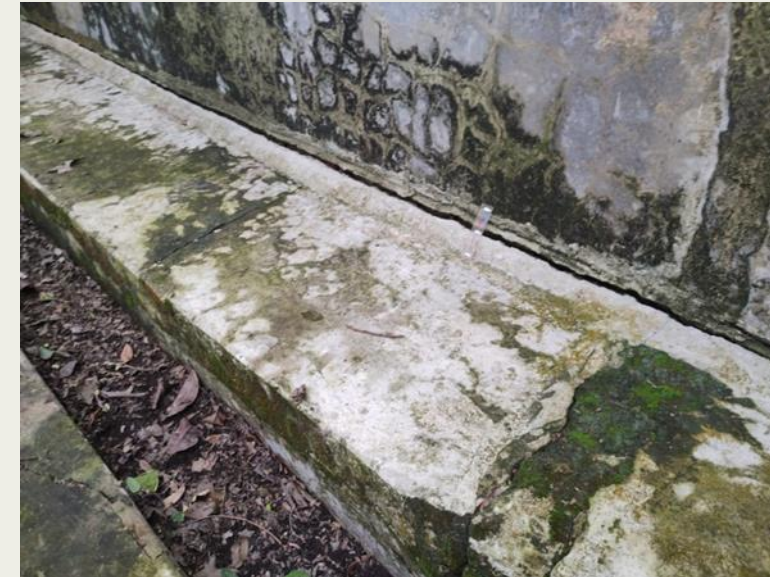
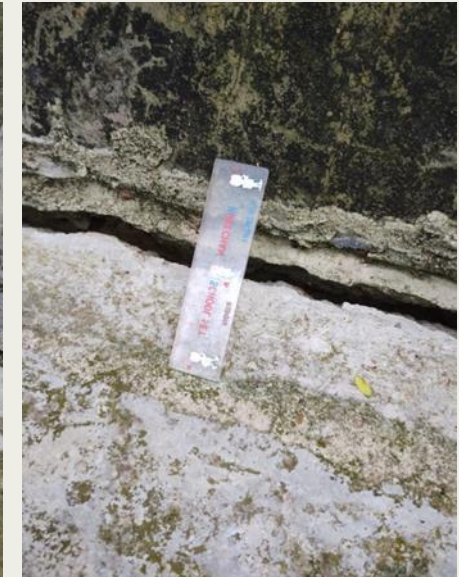
Outside of the station building

East side of the station building shows subsidence and cracks of nearly 2 cm have formed.

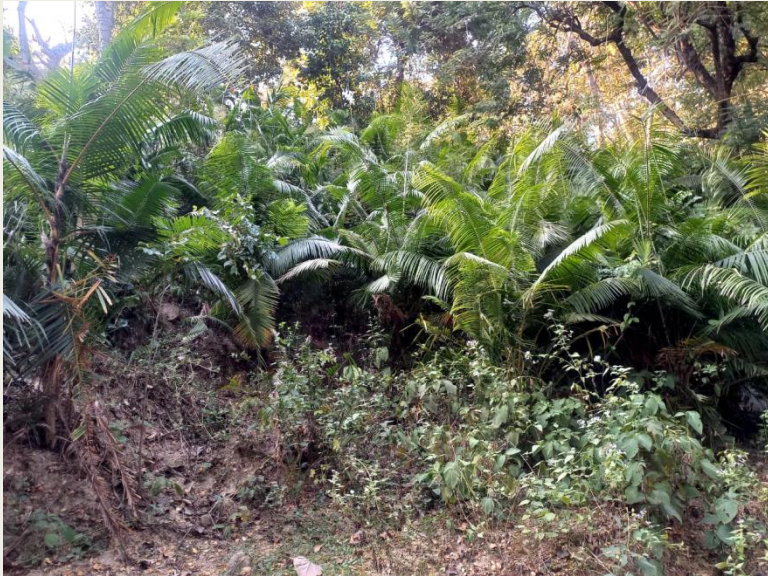
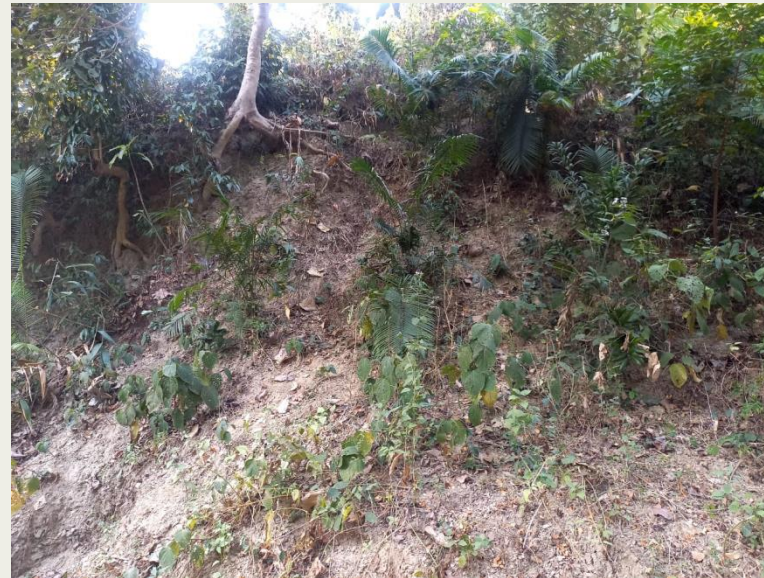
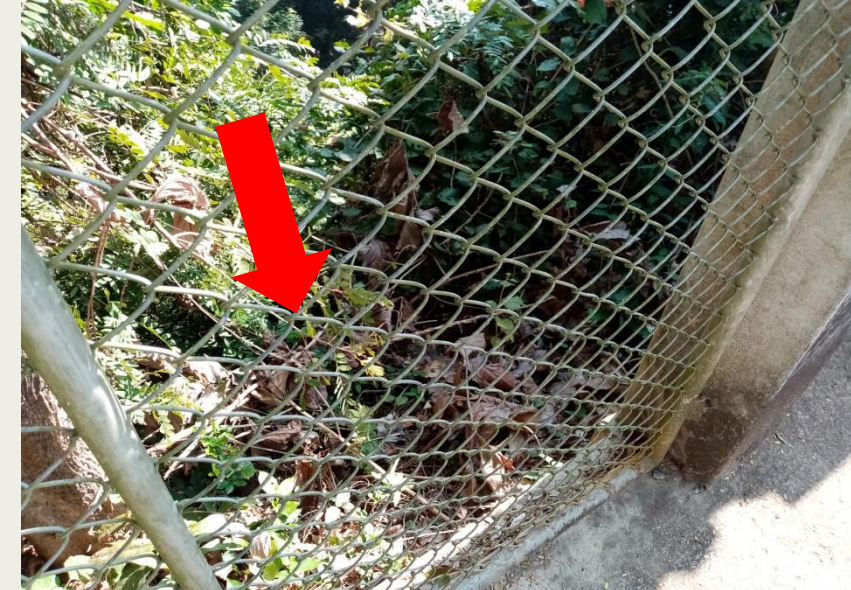
Erosion of surrounding soils of the hillock where the station is build is very much evident. Due to the erosion, subsidence and cracks of the station building were happening.
