GCI, Station and NDC Infrastructure Resilience Optimisation

Shaun Kennedy, Michael Guenther, Walid Mohammad, Mario Zampolli,
Julien Marty, Jose Pereira, Pavel Martysevich, Alfred Kramer
Poster No. P4.3-570

CTBTO IDC/OPS/GNO

The objective of this presentation is to give an overview of how information from a Network Management system(NMS) can be used to analyse incidents where there is an outage in data transmission to determine the root cause and identify improvements required to the infrastructure.

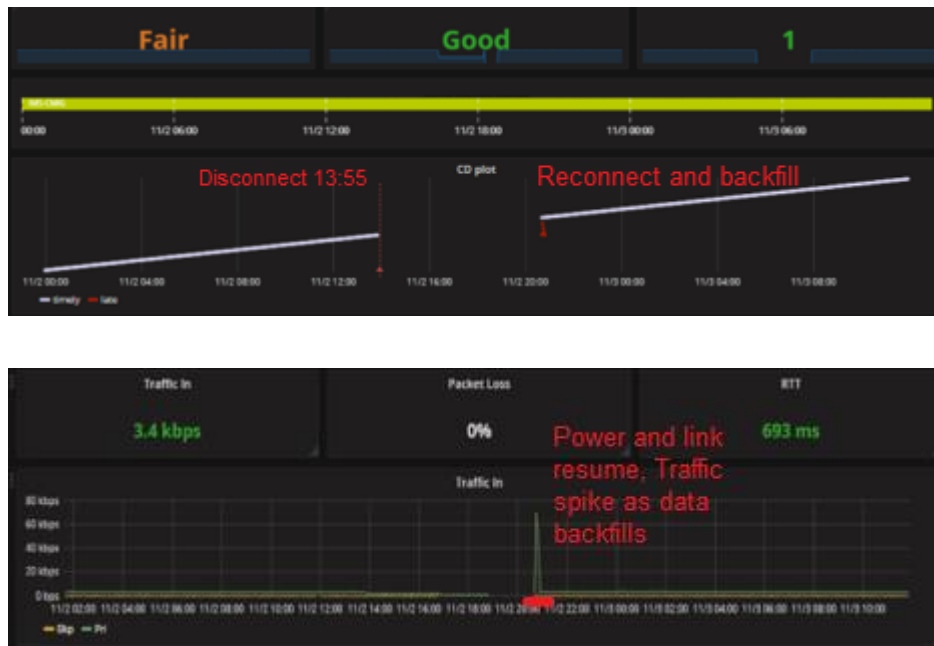
Here we see an expanded view of the GCI link SoH monitoring with the timeline for the relevant events marked up.

- 13:16** Power cut detected
- 13:50** SOH shows disconnect and traffic level drop
- 16:48** Backup GCI link Fails
- 18:48** Primary GCI link Fails and we lose connection to the station.

Result: Timely Data outage for 4 Hrs 58 minute despite an operational GCI link.

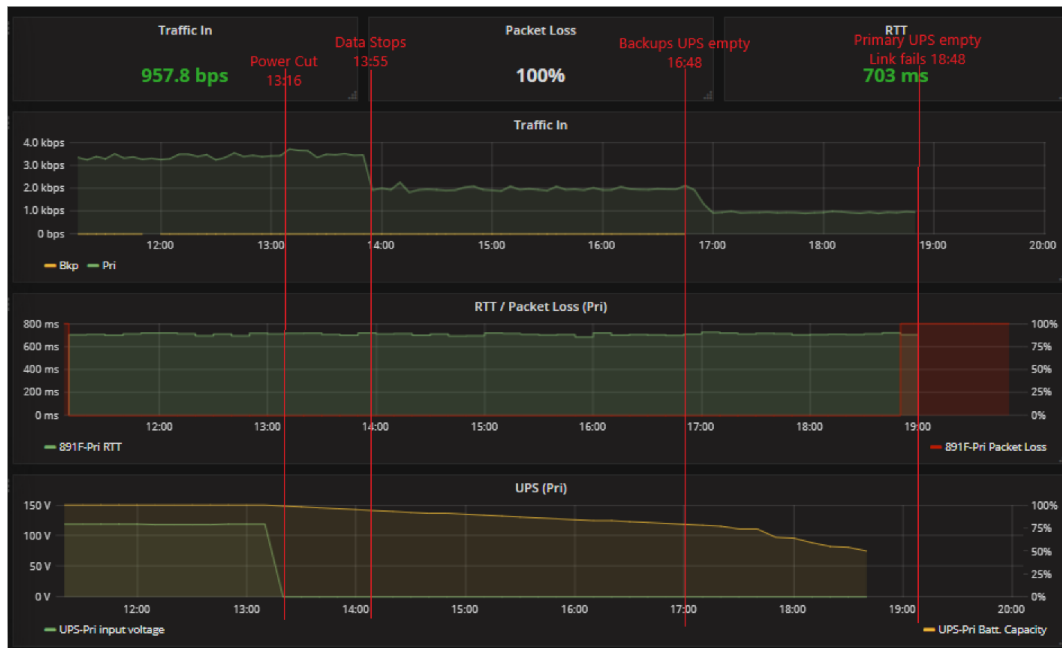
This view of the primary GCI router shows more detail.

Data stopped at 13:50

Link OK until 18:48

Power and link restored at 20:35

Traffic resumes with significant bandwidth increase as the data acquired during the outage is backfilled.

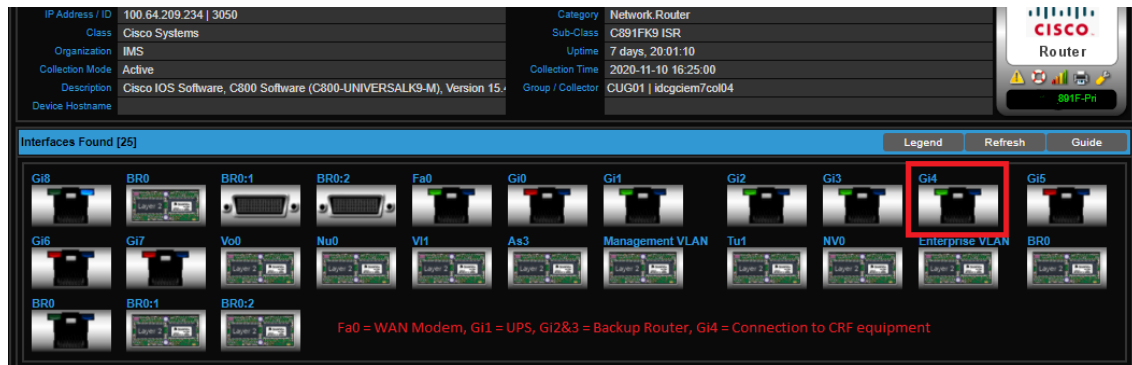
The top image is a graphical representation of the GCI router and below that we have the same information in text format from the command line of the device.

We are interested in Interface Gi4 in – red outline as this is the connection to the CRF equipment.

These logs from the central log repository are particularly relevant as they show that the ethernet port connecting the GCI router changed state to down at **13:50** which correlates with the disconnect in the data flow and reconnects at **20:39** when the power is restored.

The logical conclusion was that the device connected to this port had either failed or more likely lost power but this was 34 Min after the power cut at the location was detected.

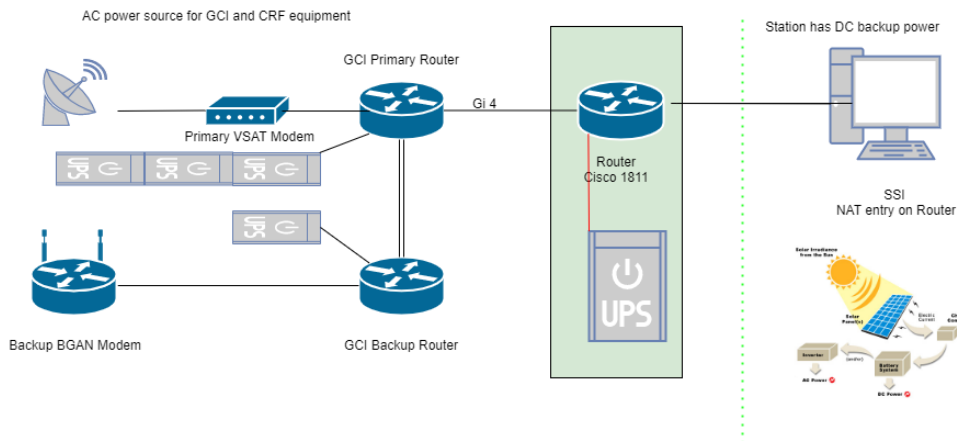
Coordinating with the SO it was identified that this device:

- Is a Cisco Router and provides isolation between the GCI and dedicated national communications link.
- Has only 2 physical interfaces so cannot be connected to both GCI routers and the CRF network.
- Requires an AC supply and the main power source at the location is DC.
- Powered via an old UPS which gives a very short run time @ **34 Min.**

Installation of an upgraded UPS to increase the runtime

Replacement of the router with a DC version powered by the station backup power, with more interfaces to facilitate physical connection to both GCI routers.
