Challenges in using RF link for intra-site communication at IMS waveform stations

S. Stefanova, C. Johannsen, S. Bazarragchaa

P4.3-558

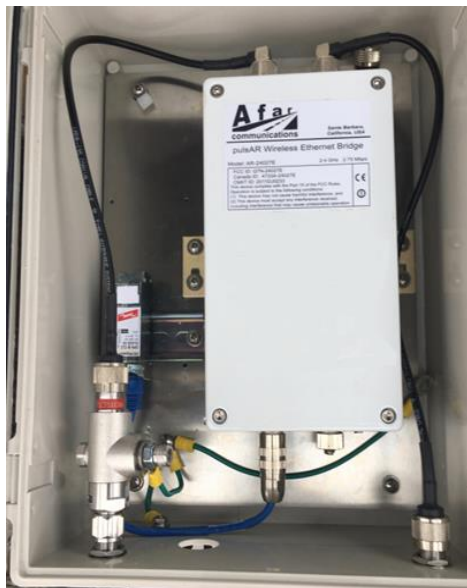
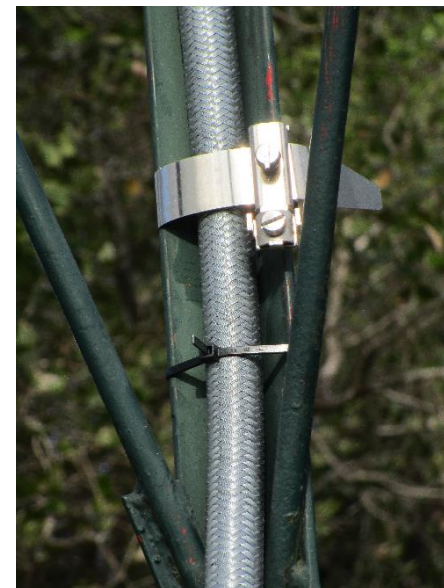
DEHN DGA AG N-type and DEHN DPA M CLE RJ45B48 surge arrestors are easily mounted inside the protection enclosure and are used to protect the radio modem both sides – RF and power/communication respectively. Another DEHN DPA M CLE RJ45B48 Ethernet surge arrestor is installed inside the equipment enclosure, at the entrance of the comms box, where power supply and Ethernet switch are installed.

It is also important to keep the radio masts grounded and install cables in metal conduits, tied closely to the radio masts.

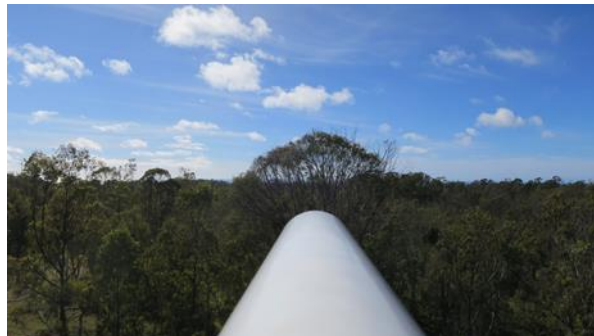
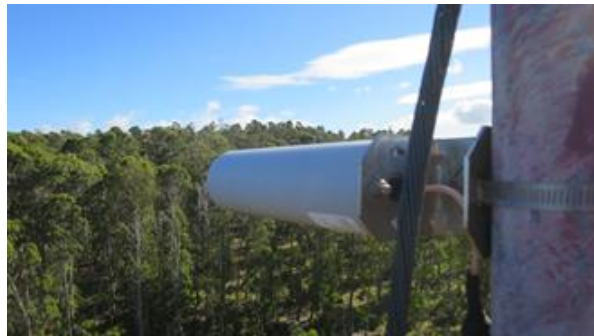
Since many stations have been operational for more than 15 years, it has also been seen that trees have grown to a size that is now affecting and disturbing the radio links. Careful planning must be taken to keep the link paths free or alternative routes or communication setup must be installed.
